Info Cement type Fly ash Microsilica Slag W/C, apparent Air %	SRPC - - - 0.40-0.45 5	Comments Core taken in 1995 Section No: Niras T681-1top A4
---	--	---------------------------------------	---

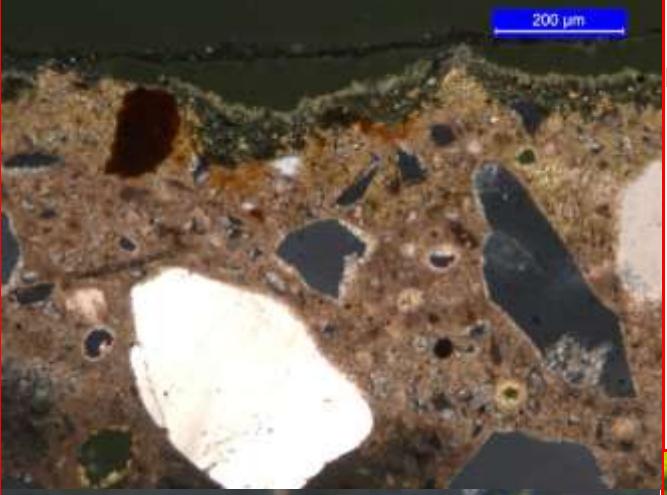
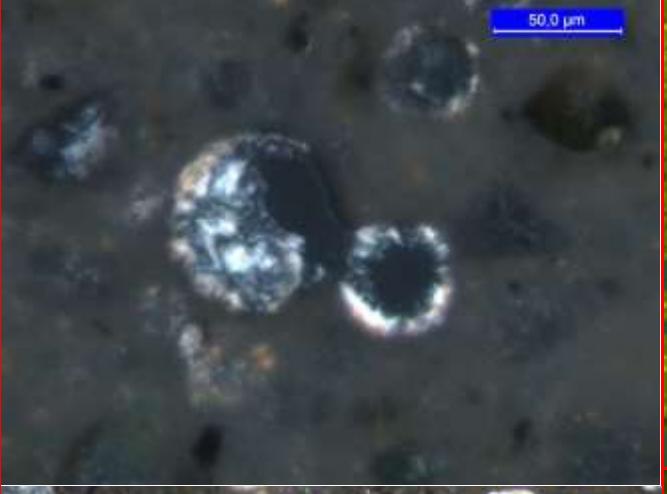
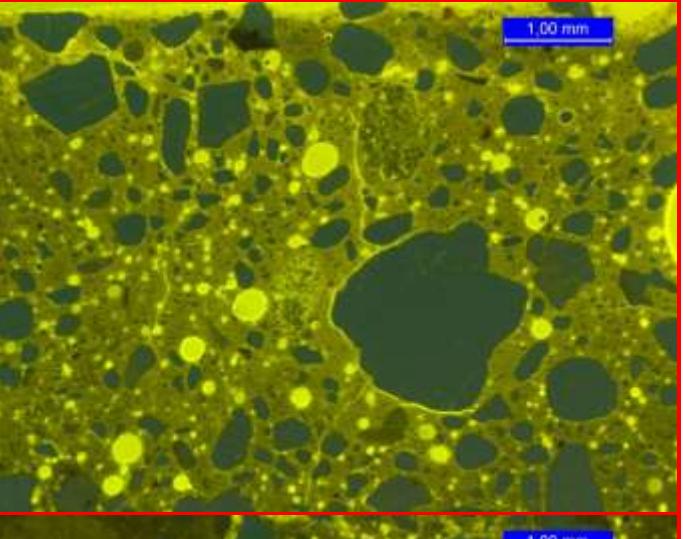
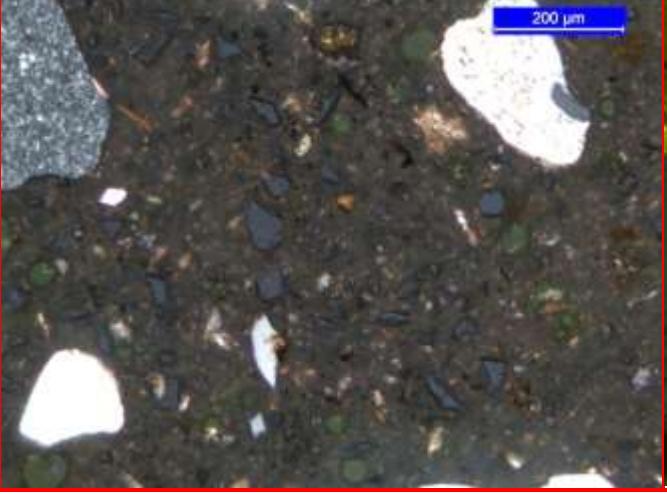
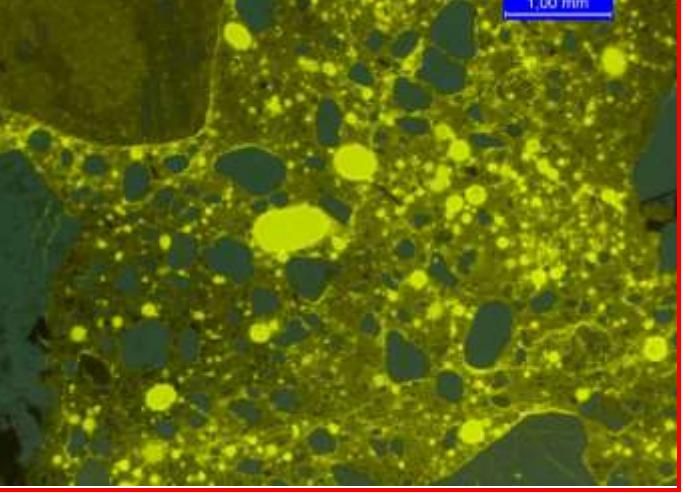
Info Cement type Fly ash Microsilica Slag W/C, apparent Air %	Slag - - X 0.30-0.35 6	Comments Core taken in 1995 Section No: Niras T681-3top C4
---	--	---------------------------------------	---

Micro-observations Micro-structural zoning through concrete: <ol style="list-style-type: none"> 0.08mm: Leached, porous, scaled surface. Sand grains are exposed. Paste appears rusty red and damaged from biological growth. 0.08-0.8mm: Carbonated paste. Slag grains are carbonated. Some microcracking in paste. 0.8-1.2mm: Dense highly opaline zone with thaumasite-like phases in voids. 2-45mm: Internal paste contains low amount of small CH crystals. Paste appears very dark. Green paste coloration is observed.

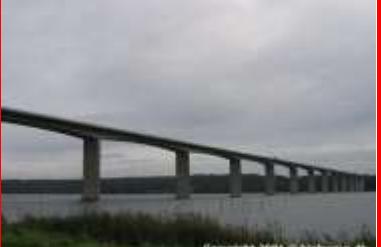
Info Cement type Fly ash Microsilica Slag W/C, apparent Air %	Slag - - X 0.35 5-6	Comments Core taken in 2012
Section No: 7206-V1

1. Surface: Leached, porous, scaled surface. Distinct rusty coloration. Sand grains are exposed.
2. 0-2mm: Partially, carbonated zone with patchy appearance (popcorn). Dense, cracked paste. Air voids filled with calcite. Slag grains are carbonated. Enriched in Mg.
3. 2-6mm: Porous, opaline zone with thaumasite-like phases and ettringite in air voids and relict after cement grains. Highly increased in S.
4. >6mm: Internal paste appears very dark. Greenish coloration of paste present, throughout. Dense paste with autogeneous micro-cracks. Ettringite in air voids to 18mm. Friedelsalt present in relict of cement grains; increased Cl from 3-60mm.

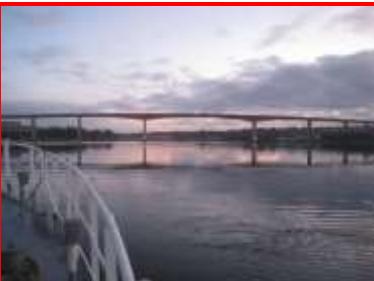
Info Cement type Fly ash Microsilica Slag W/C, apparent Air %	CEM I 42,5 SR - - - 0.45 7	Comments Core taken in 2012 Cement type: New low alkali, so called ALS Section No: 7206-A3
---	--	---	--

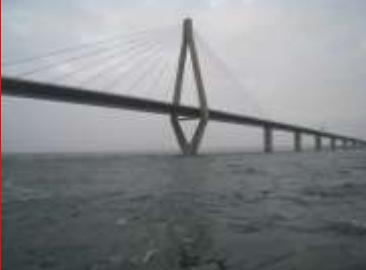
Info Cement type Fly ash Microsilica Slag W/C, apparent Air %	LavAlk X - - 0.40 3-4	Comments Core taken in 2012 Cement type: Lavalkali Section No: 7206-F3
---	--	--------------------------------------	--

Micro-structural zoning through concrete: 1. Surface is uneven and scaled. A thin calcite crust is occasionally observed, as well a paste damaged by biological growth. 2. 0-3mm: Partially carbonated paste with bands of black paste. Massive ettringite and thaumasite-like phases are observed in air voids. Paste is highly cracked. Popcorn carbonation in the bottom of the zone. 3. 3-10mm: Porous, black paste with ettringite and thaumasite-like phases in air voids. 4. Internal paste contains a relatively high amount of CH. Observed in air voids too. Many small autogeneous cracks in paste.

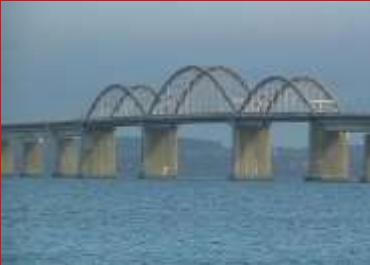
<p>Info</p> <p>Cement type Fly ash Microsilica Slag W/C, apparent Air %</p>	<p>PC? - - - -</p>	<p>Comments</p> <p>Cores taken in 2012 (Rambøll) Cement type: PC (?) Section: RAMBØLL 7234-7UV</p>
---	--	------------------------------------	---

1. Surface is uneven and weakly scaled. A calcite crust is typically observed at the surface.
2. 0-0.7mm: Cracked decalcified paste highly enriched in Mg. Calcite appears intermixed in the decalcified paste. Popcorn carbonation appears in the bottom of the zone.
3. 0.8-13mm: Zone containing a high amount of ettringite in small cracks, air void and in relicts after cement grains. Some cracking of paste.
4. 9->33mm: A very high amount of Friedelsalt is present in relicts after cement grains.

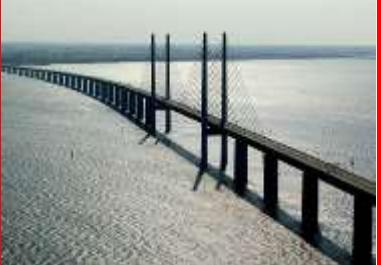
Info Cement type Fly ash Microsilica Slag W/C, apparent Air %	CEM I 42,5 SR - X - 	Comments 4 cores taken in 2011 Core F16-17 above water Core H23 above water Core J28 below water Cement type: Swedish Section No: 7090
---	--	--------------------------------------	---

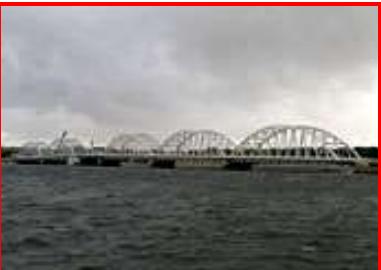
Info Cement type Fly ash Microsilica Slag W/C, apparent Air %	?	Comments Core taken in 1995 Pillar found on bottom of fjord ASR UHJ section (rap188)
---	--	---	---

Micro-observations Micro-structural zoning through concrete: <ol style="list-style-type: none">1. Surface is intact and covered by a crust of fine sand cemented together by calcite.2. 0-0.8mm: Thin carbonated zone3. 0.8-0.4 (5)mm: Leached paste without CH; deepest where fine surface cracks appear. Increased porosity.4. 5-45mm: Paste containing well distributed CH. CH is filling air voids. The concrete is heavily cracked from ASR; gel, CH and ettringite are present in cracks.

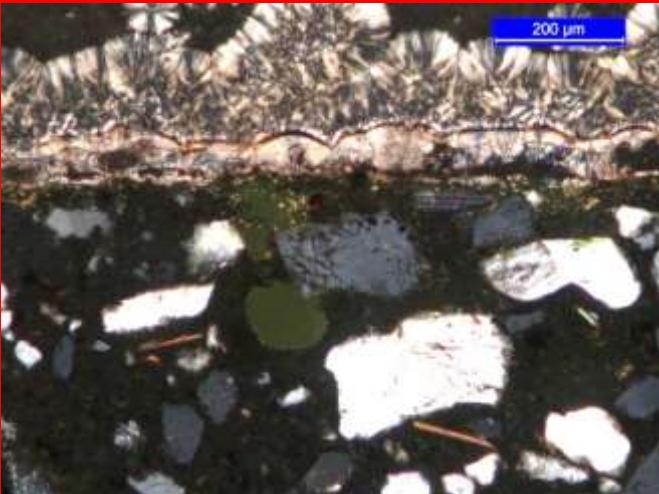
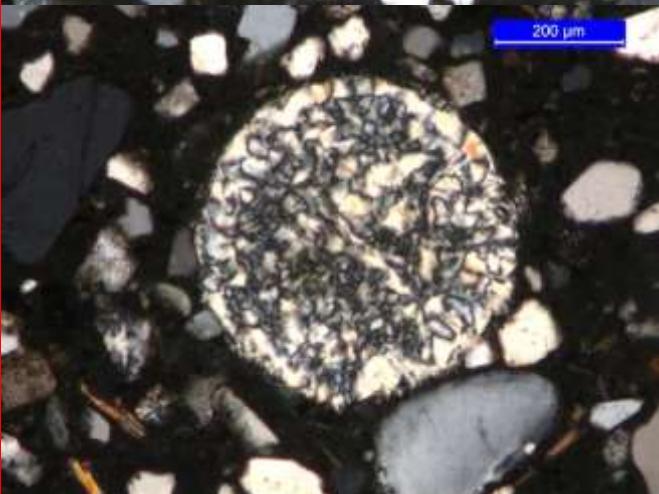
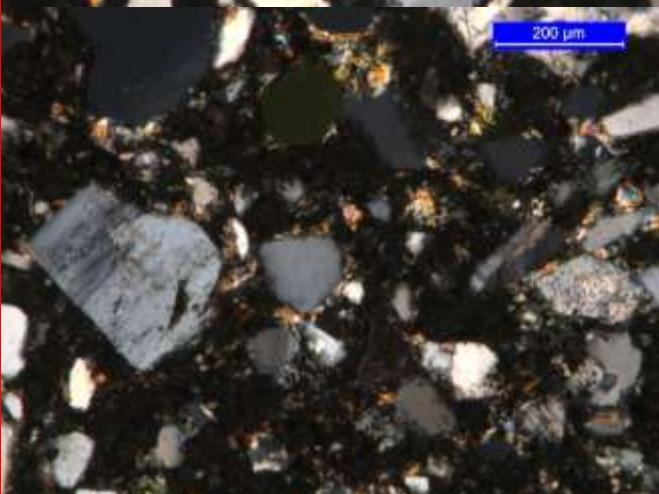
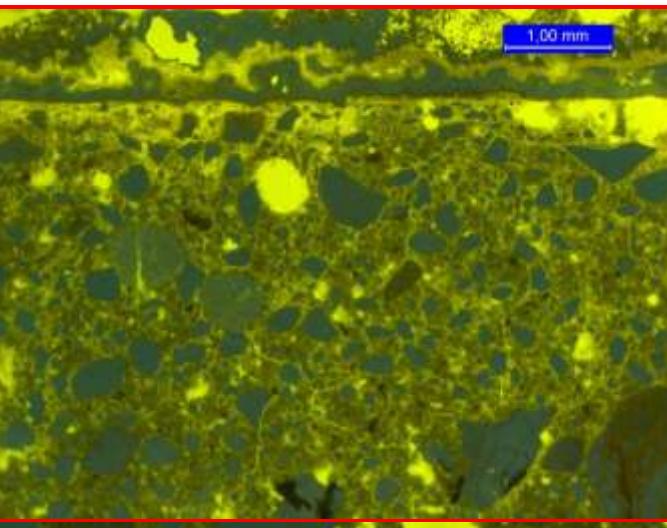
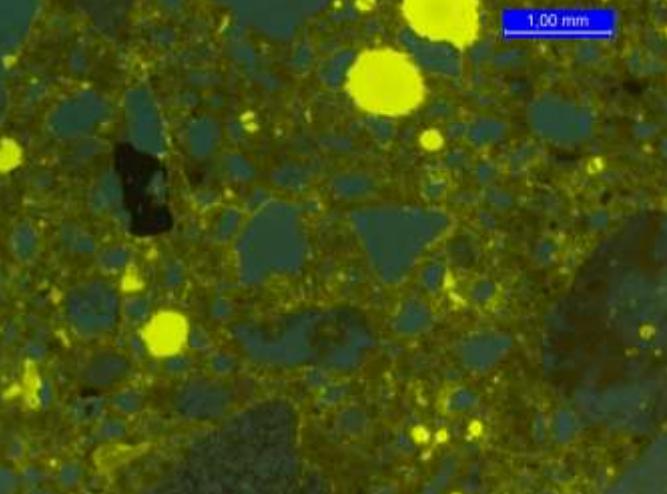
Info Cement type Fly ash Microsilica Slag W/C, apparent Air %	PC (R) - - - 0.35 <1	Comments Core taken in 1995 Concrete mix 1:2:3 Local aggregate with porous flint UHJ section (rap137)
---	--	-------------------------------------	--

<p>Micro-structural zoning through concrete:</p> <ol style="list-style-type: none"> 1. Surface is intact and covered by a layer of alternating calcite and brucite, $Mg(OH)_2$ 2. 0-28mm: Leached porous paste with ettringite/brucite/thaumasite in air voids. Increased paste porosity. Some micro cracking of paste. 3. 28-45mm: Paste containing very large CH crystals in void spaces and air voids.

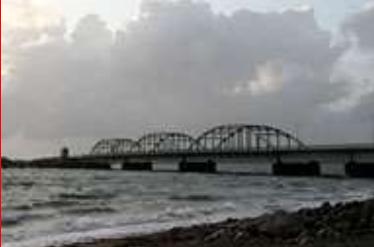
Info Cement type Fly ash Microsilica Slag W/C, apparent Air %	PC (A) - - - 0.40-0.60 <1	Comments Core taken in 1992 Na ₂ O of cement: 0.6-0.8 Concrete mix 1:2:3 Local aggregate with porous flint UHJ section (rap108)
---	--	--	--

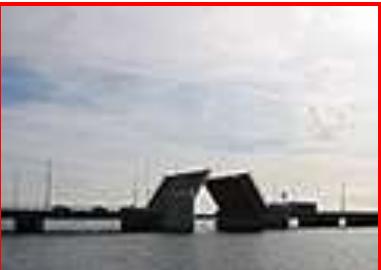
Info Cement type Fly ash Microsilica Slag W/C, apparent Air %	PC (A) - - - 0.45 2	Comments Core taken in 1996 Cement: 355 kg/m ³ W/C = 0.47 (mix) Granite aggregate, few porous flint in sand (minor ASR) UHJ section (rap196)
---	--	------------------------------------	---

1. Relatively straight surface occasionally covered by calcite and brucite. No exposed aggregate. A thin rusty zone appears at interface to concrete.
2. 0-2mm: Distinct carbonated zone with a fine crack through concrete. The crack divides with depth. Carbonated paste along crack; brucite and calcite in crack.
3. 2-45mm: Paste rich in large CH crystals. Towards the crack the paste becomes totally leached (black) with massive ettringite in air voids. Popcorn carbonation is also observed close to crack.

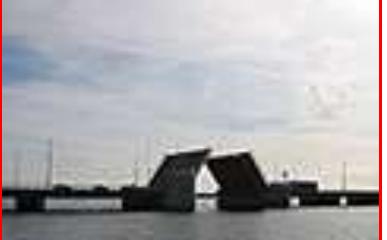
Info Cement type Fly ash Microsilica Slag W/C, apparent Air %	PC (A) - - - 0.45	Comments Core taken in 1996 Porous flint in both aggregate fractions (Fill concrete). ASR UHJ section (rap223)
---	--	-------------------------------	---

<ol style="list-style-type: none"> Wavy surface, no exposure of aggregate. Occasionally calcite crust. 0-12mm: Distinct carbonated surface, very irregular front. Soft crack appears through concrete, paste is carbonated along this to 35mm depth. 12-45mm: Paste containing very large CH crystals in void spaces and air voids. The paste appears leached (black) towards the crack with massive ettringite in air voids. Some popcorn carbonation near crack.
