Petrographic evaluation after 5 years of exposure to seawater

Microanalyses of 5 years old concretes from marine exposure compared to the 28 days (non-exposed concrete), the 6 months and the 2 years analyses of the same concretes.

Micrographs shown are mostly from the Western side of panels and taken in fluorescent light mode (green), polarized og x-polarized light.

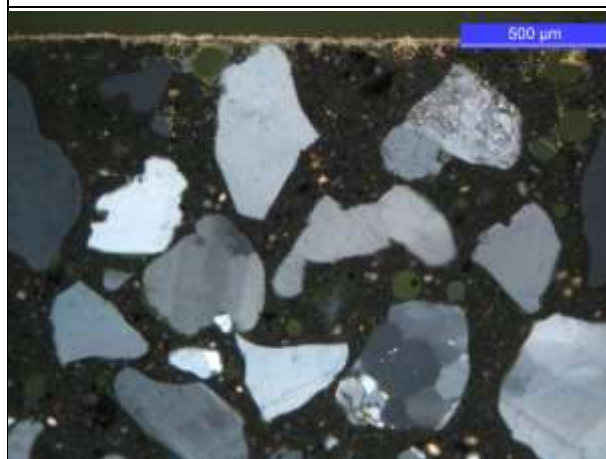
Age 6 mth's

1. Leached zone behind carbonation: from 0.1-0.5 mm (W), 0 mm (E).
2. Popcorn carbonation: Not distinct.
3. Opaline paste behind popcorn carbonation: from 0.5 -2.5 mm (W), to 2.2 (E).

Ettringite: Needles are observed in air voids near the surface.

Porosity: Increased in the outer 2 mm (W), 1.8 mm (E).

Cracks: Brittle micro-cracks in the surface regions.

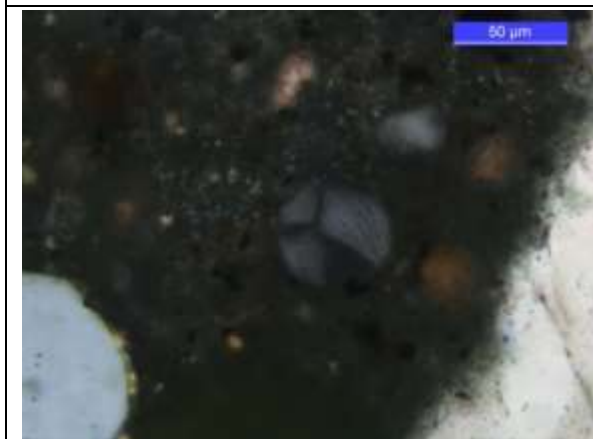
Based on the structural appearance, the outermost surface region can be divided into 3 zones:

1. Leached zone behind carbonation: from 0.2-0.4 mm (W & E).
2. Popcorn carbonation: from 0.4-0.6 mm (W & E).
3. Opaline paste behind popcorn: From 0.6 to 2 mm (W), from 0.6-0.8 mm (E).

Ettringite: Needles in air voids to 0.6 mm (W), 1 mm (E).

Porosity: Increased in outer 1 mm (W), 0.8 mm (E).

Cracks: Some brittle paste cracks in the outer leached zone. Generally no cracks in interior paste.

Air: Ok air void structure.

Gypsum: Observed in an air void near the surface (W).

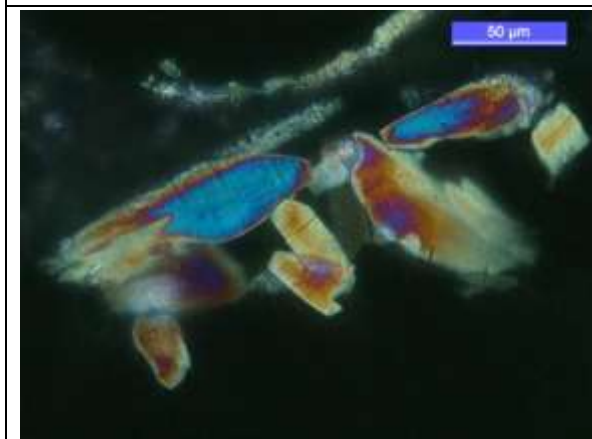
Carbonation: to 0.2 mm (W & E). Calcite crystals in voids. Rusty spots present in carbonated zone.

Based on the structural appearance, the outermost surface region can be divided into 3 zones:

1. Leached zone behind carbonation: from 0.2-0.4 (W), from 0.2-0.3 (E).
2. Popcorn carbonation: from 0.4-0.7 mm (W), from 0.3-0.6 mm (E).
3. Opaline paste behind popcorn: from 0.7-2.4 mm (W), from 0.6-1.2 mm (E).

Ettringite: Needles in air voids in especially the leached paste where it appears more massive, to 1 mm (W), to 0.6 mm (E).

Porosity: Increased in outer 1.5 mm (W), not observed in E section.

CH: Very large crystals observed in interior paste below leached zone.

Cracks: Many small brittle micro-cracks in the outer leached zone.

Gypsum: Observed in few air voids near surface (W).

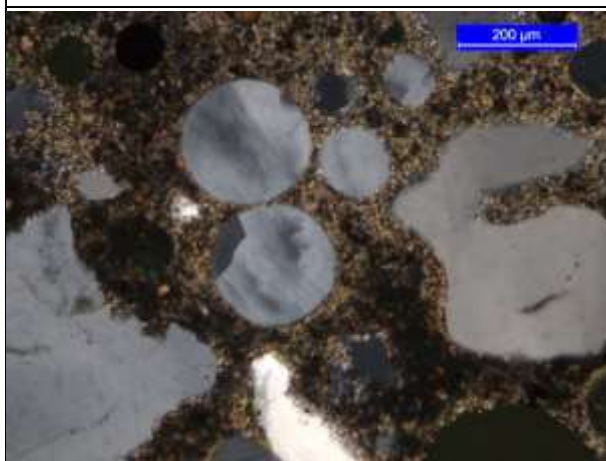
Based on the structural appearance, the outermost surface region can be divided into 3 zones:

1. Black zone behind carbonation: Distinct, from 0.2-1 mm (W), from 0.2-0.4 mm (E).
2. Popcorn carbonation: from 1-2 mm (W), from 0.4-0.8 mm (E).
3. Opaline paste behind popcorn: from 2-4 mm (W), from 0.8-3.5 mm (E).

Ettringite: Needles in air voids throughout but most intense outer 18 mm (W), 13 mm (E). Distinct orange birefringence of "ettringite" near popcorn zone.

Porosity: Increased porosity in outer 2 mm (W), 1 mm (E).

Cracks: Small brittle micro-cracks in outer leached zone.

Gypsum: Observed in several air voids in the popcorn carbonated zone (W & E).

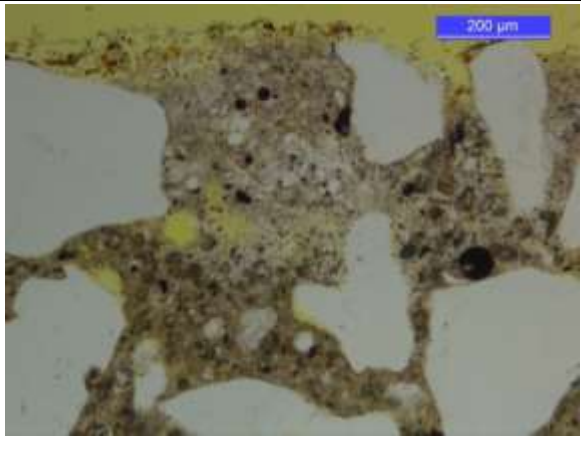
<p>Micro-observations (6 months images)</p> <p>Surface: Scaled (E) to partly scaled with exposed sand grains. Biological growth at surface.</p> <p>Carbonation: to 0.3 mm (W), 0.2 mm (E). Calcite crystals in voids. Rusty spots present in carbonated zone.</p> <p>Based on the structural appearance, the outermost surface region can be divided into 3 zones:</p> <ol style="list-style-type: none"> 1. Leached zone: From 0.3-0.4 mm (W), not distinct in (E). 2. Popcorn carbonation: from 0.4-0.5 mm (W), not distinct in (E). 3. Opaline paste behind popcorn: from 0.5-1.2 mm (W), to 1.2 mm (E). <p>Ettringite: Observed in the few air voids, but not distinct.</p> <p>Porosity: Increased porosity in outer 0.8 mm (W & E).</p> <p>Cracks: Some smaller brittle micro-cracks in the outer leached zones.</p> <p>Air: Low content, not entrained.</p> <p>Gypsum: Not observed.</p>
