MICROSTRUCTURAL SURFACE DETERIORATION OF CONCRETE EXPOSED TO SEAWATER; RESULTS AFTER 2 YEARS EXPOSURE

Ulla Hjorth Jakobsen

Danish Technological Institute, uhj@teknologisk.dk

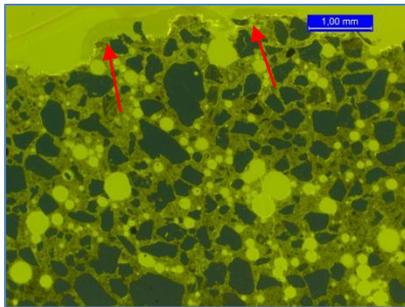
Figure 1: Example of weakly scaled surface. Fluorescent light mode.

The surfaces of the concrete, except for Concrete A and B, all show signs of weak scaling (Figure 1) after 2 years of exposure to seawater. Often the paste at the surface is carbonated (Figure 2) and air voids more or less filled with calcite is observed. Based on mineralogy and morphology of phases the optical microscopy observations show very clearly that the concrete can be divided into different zones inwards from the exposed surface (Figures 2 and 3). The paste of the outermost concrete, is as mentioned, carbonated. Behind the carbonated paste a zone completely black in X-polarised light appears. This zone is apparently relatively dense (dark green in fluorescent light) and rich in short, brittle cracks having no preferred orientation (Figure 4). The zone is gradually replaced by another zone with a somewhat black, but distinct opaline paste where calcium hydroxide is present but almost invisible due to the opaline shine. The interface between the cracked zone and the opaline zone is usually marked by porous paste containing small rounded calcite rosettes, the so called popcorn carbonation. The air voids of the opaline zone occasionally contain gypsum (Figure 5) and a thaumasite-like phase (Figure 6). Ettringite is distinct in air voids especially of the opaline zone, but occurs throughout the concrete with a decreasing amount at greater depth. Behind the opaline zone the paste looks “normal” with well distributed CH and well hydrated paste.

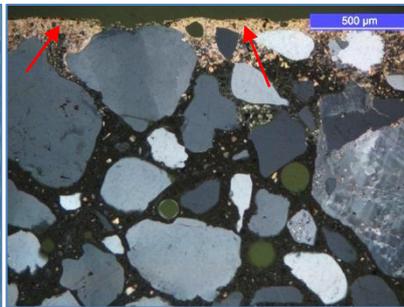
Figure 2: Carbonated paste at the surface is recognized from the brownish colour. X-polarised light-

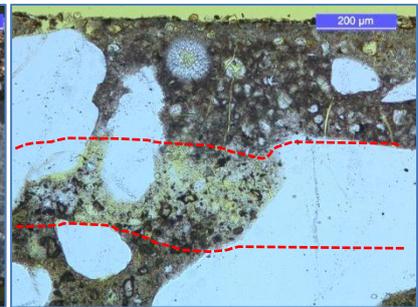
Figure 3: Distinct zoning of the surface region of the concrete. Polarised light.

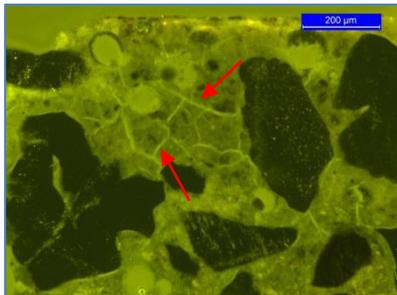
Figure 4: The outer zone of the concrete is rich in short brittle cracks. Fluorescent light mode.

Generally the concrete contains only few cracks except for the brittle ones at the surface (Figure 4). Few fine (10-100µm wide) cracks are observed from the surface into the concrete to depths of max. 12mm; most of these appears to have formed when the concrete was relatively young.

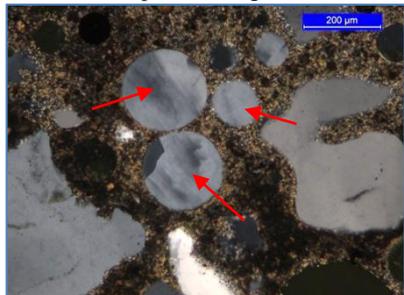
Figure 5: Occasionally air voids in the surface region are filled with gypsum. X-polarised light-

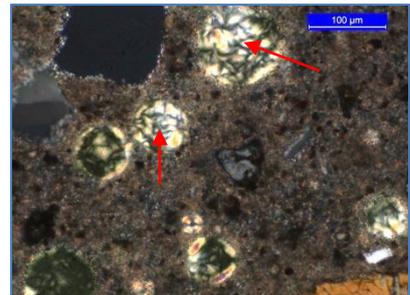
Figure 6: In other occasions thaumasite-like phases are present in the air voids.

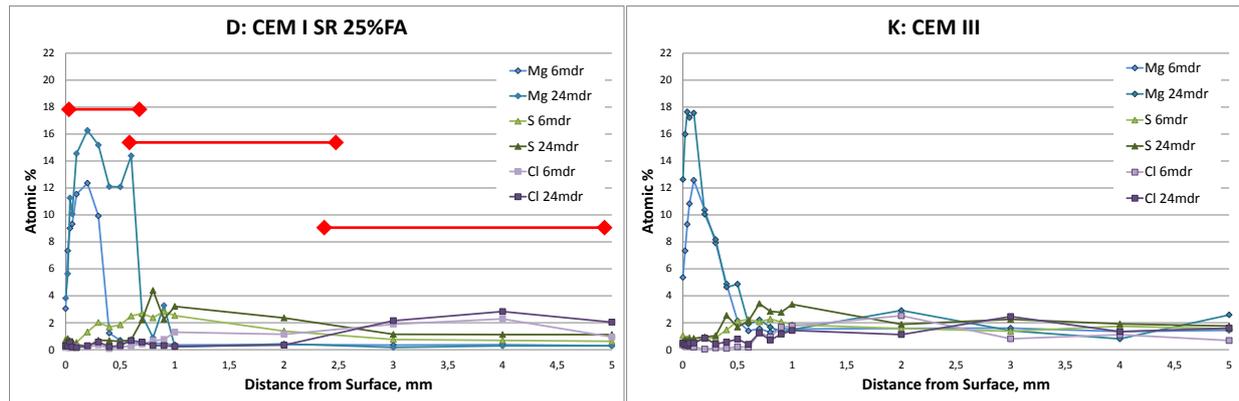
Figure 7: Examples from Concrete D and K of the variation of Mg, S and Cl with depth and exposure time. The red bars indicate the position and extend of the 3 zones (the chloride-zone is deeper than shown on the Figure, where the x-axis is cut off at 5mm).

In order to add more information about the surface changes seen during optical microscopy the concrete were further analysed using SEM-EDX. This analysis shows that the surfaces of all the examined concrete distinctly can be divided into 3 chemical zones (Figure 7), three zones which coincide with the optical observations. The zones are defined based on atomic%, Mg-zone >0.5, S-zone 1.5-3.5, and Cl-zone 0.75-4 atomic%.

The zoning observed (mineralogical as well as chemical) was in most of the samples already observed after 6 month of exposure; after 2 years the zoning is more distinct in some of the concrete, while in others only little progressions is observed (Table 2). The zoning can be divided into 3 main zones (Figure 7); the outermost typically less than 1mm deep is enriched in magnesium and silicon, Mg and Si. The second zone to maximum of 13mm in depth is enriched in sulphur, S. The third zone is enriched in chloride, Cl (>0.75 atomic%), and can in one concrete be traced to a depth of 70mm. The 3 zones show only a slight overlap with each other.

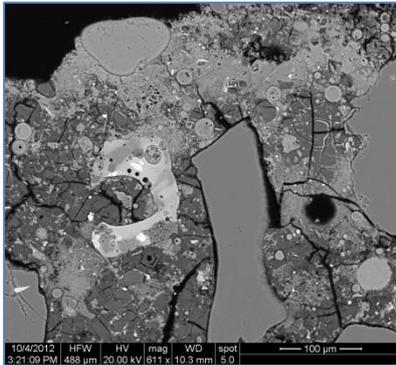
Figure 8: Example of deteriorated surface. The paste consists of mainly Mg-Si (dark grey) and areas of calcite. The zone is distinctly cracked and the surface is scaled. CEM I SR concrete with FA and SF. Backscatter image.

Typically none of the concretes show sign of brucite, MgOH₂, precipitation at the surface, except for concrete B containing 15% FA which after 2 years of exposure was partly covered by brucite. All the other concrete shows after 2 years a max. 1mm cracked zone in the surface (Figure 8) where the paste is more or less decalcified. This zone appears to be equal to the observed black zone observed in X-polarized light. The zone consists almost exclusively of Mg and Si. Plotting the atomic ratios of Al/Ca versus the Mg/Ca show that the paste of this zone consist of a magnesium silicate hydrate, except for in concrete K (CEM III/B) and in concrete Basis (CEM II/A-LL) where the main phase is hydrotalcite. The calcite popcorns at the interface to the S-zone corresponding to the opaline zone in X-polarised light are also observed in backscatter mode (Figure 9). The S-zone varies slightly

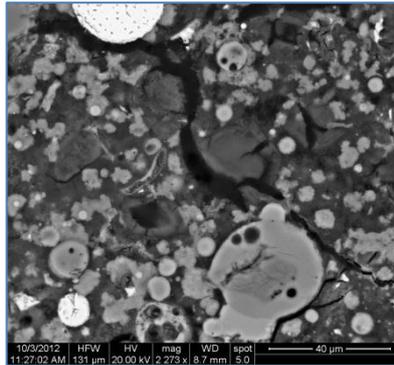
Figure 9: Typical appearance of the popcorn carbonated zone between Mg- and S-zones. "Popcorn" appears as small light grey irregular spots (not to be confused with the spherical fly ash particles). CEM I SR concrete with FA. Backscatter image.

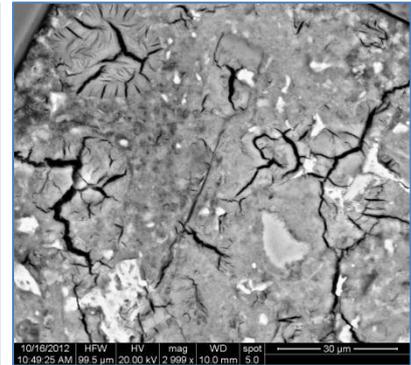
Figure 10: The S-zone behind the Mg-zone is highly enriched in ettringite in e.g. air voids and relicts after cement grains. This zone occasionally contains thaumasite and gypsum in air voids. Note the cracking of ettringite is an artefact which forms in the SEM due to dehydration/shrinkage of the H₂O-rich phase. Concrete with pure CEM I 52.5. Backscatter image.

in thickness, the thinnest zones are found in concrete A, B, Basis and Rapid+FA; the thickest zone of 13mm in concrete K containing pure CEM III/B. The S-zone contains a relative high amount of ettringite in the paste (in relicts after hydrated cement grains), in air voids and in few small cracks (Figure 10). The infilling of the relicts after hydrated cement grains causes the opaline shine of the paste observed in X-polarised light as the light coming through the specimen is spread due to the presence of the minute small S-phases all over the paste. When the concentration of S decreases and ettringite becomes more difficult to observe within the paste, EDX analysis shows an increase of the chloride content (> 0.75 atomic%). The thickness of the Cl-zone varies from concrete to concrete being thinnest in the CEM III/B concrete and thickest in the concrete containing only CEM I (Table 2). Both optical microscopy and SEM-EDX analysis shows a distinct presence of Friedel's salt in relicts after cement grains in the Cl-zone, especially at larger depths.

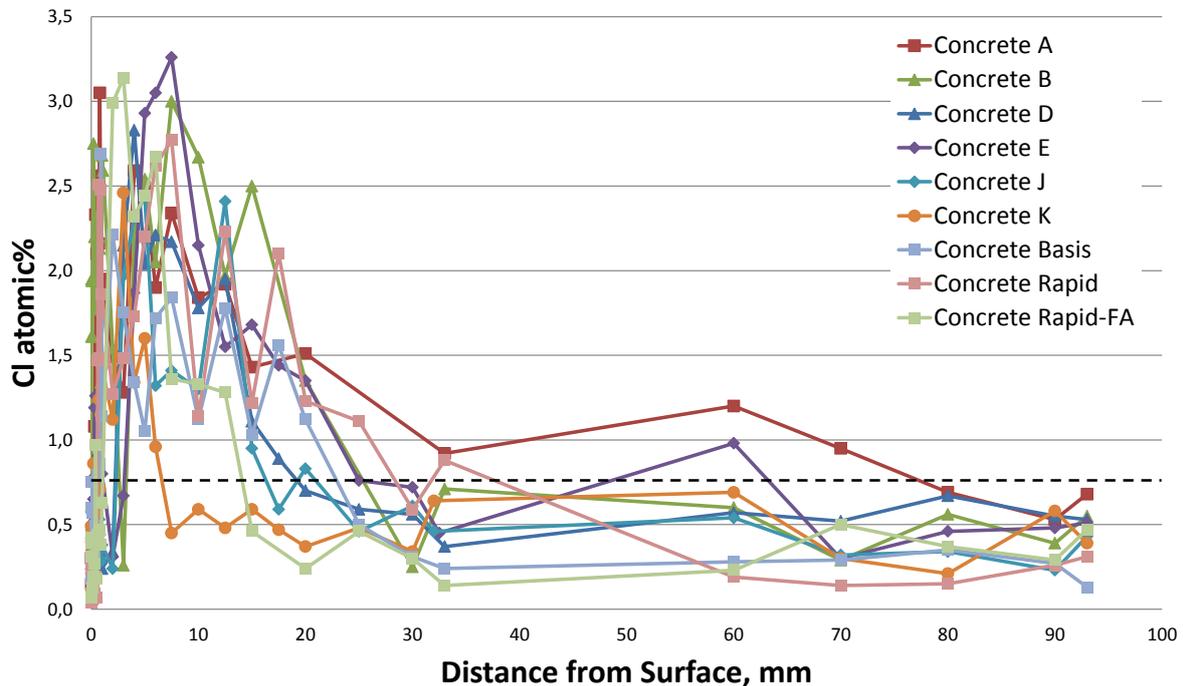
Figure 8: Cl-profiles after 24 months of exposure for the 9 examined concretes. The Cl-background values of non-exposed concrete are indicated with a stippled line. The Cl-content of concrete A does not drop under the background level before a depth of >70mm.

The Cl-zone can be traced to the deepest level in concrete A with pure CEM I SR cement (70mm) and in concrete Rapid with pure CEM I 52,5 cement (33mm) (Figure 8). Only in concrete A an increase of the depth of the zone is seen from 6 to 24 months, it increases from 20 to 70mm. In the rest of the concretes the Cl-enrichment are observed to depth of max. 20mm and almost no changes are observed from 6-24 months.
