Chloride threshold values

Meeting with the reference group

12 October 2011

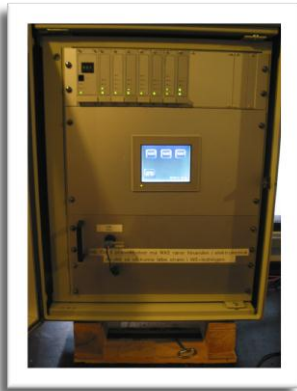
Potentiostat

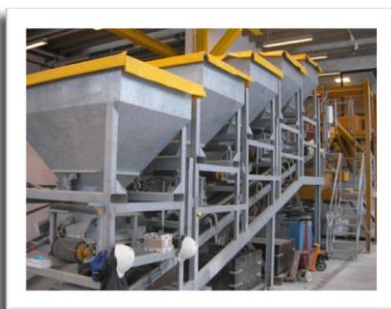
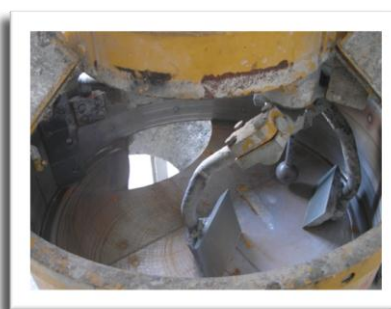
Concrete mixing station

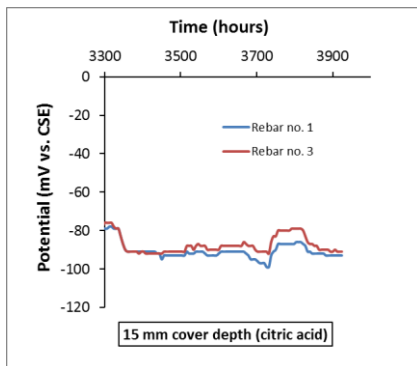
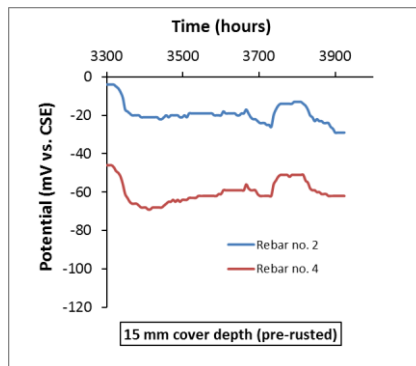
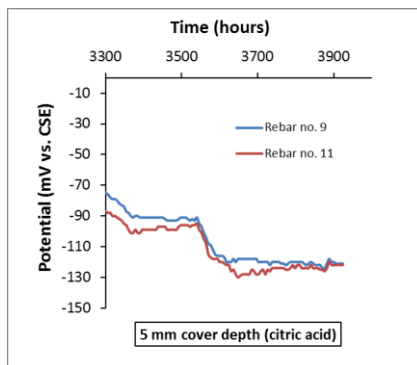
- Corrosion on-set will be detected by significant change in potential
- No indication of corrosion after 5 months of exposure.

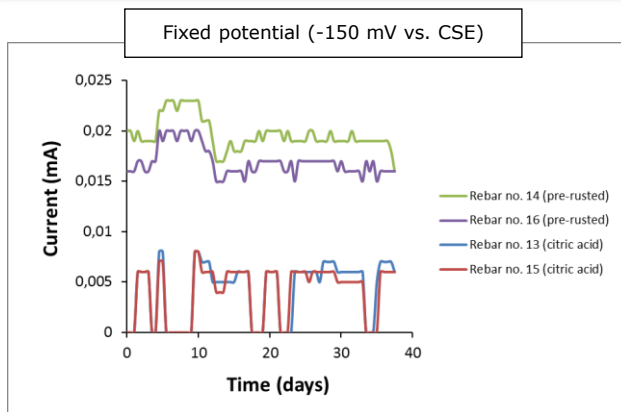
*Example of
measurements*

- Corrosion on-set will be detected by significant increase in current
- No indications of corrosion observed after 4 months of exposure

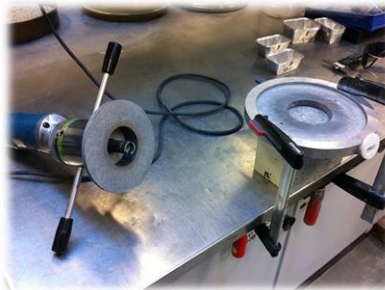
- 0 to 5 mm: Sampling in 1 mm intervals
- 5 to 15 mm: Sampling in 2 mm intervals

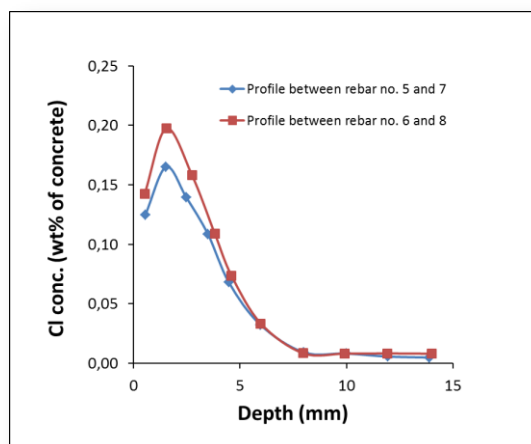
Chloride profiles

After 153 days of exposure in 6% NaCl solution (at 20°C)
